# Inspection Report

## Sample Customer

123 Sample St  
Your Town IL

### At Home Inspections, Inc.

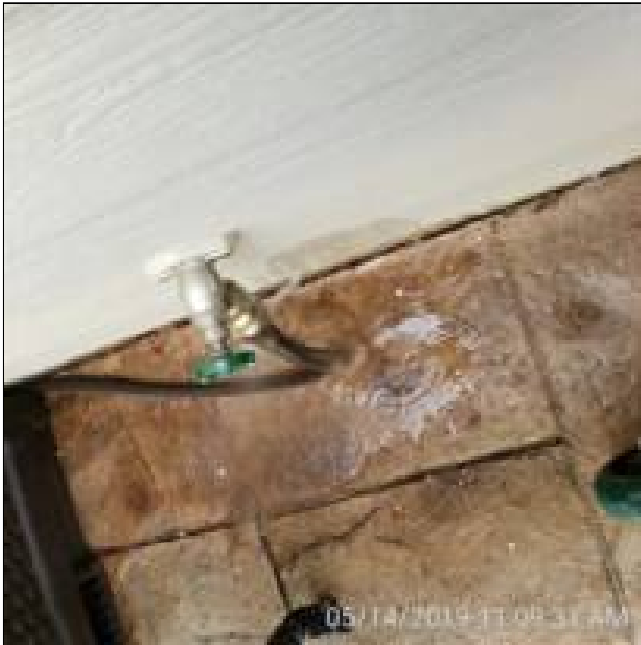
1.0 (Picture 1)

**Hose bib was leaking when in use.**

A hose bib is plumbing that allows you to connect a hose. Older hose bibs are not frost free and it is recommended that they be turned off from inside for the winter to prevent frozen pipes and water damage.

This was found at back.

Recommend asking current owner about this and qualified plumber to repair or replace to prevent water damage.

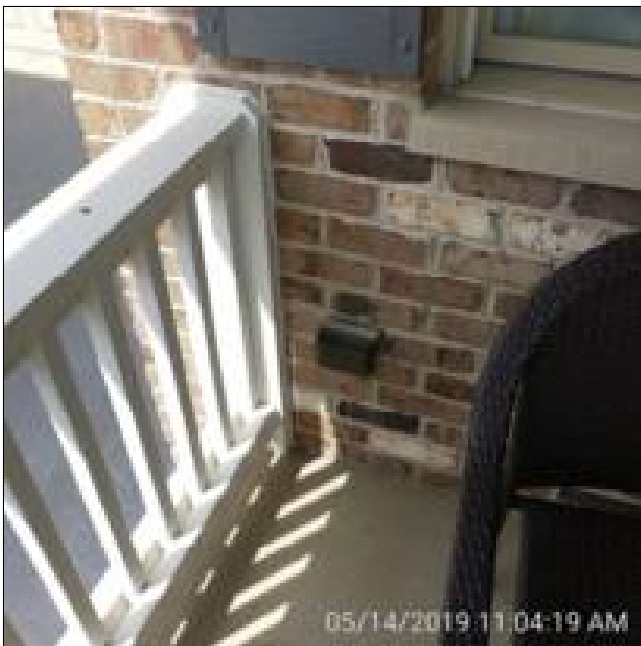
1.1 (Picture 1)

**GFCI outlet was not working.**

This was found at front.

Recommend asking current owner about this, checking for sensors or switches in unusual (or covered) locations, and qualified electrician to repair or replace as needed for normal function.

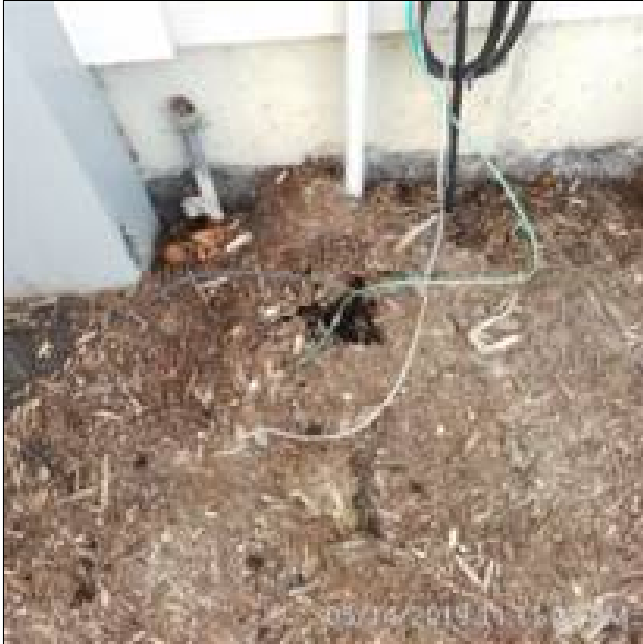
1.2 (Picture 1)

**Ground connections (appeared to be low voltage) were not connected.**

Recommend electrician to evaluate further and repair as needed for safety.

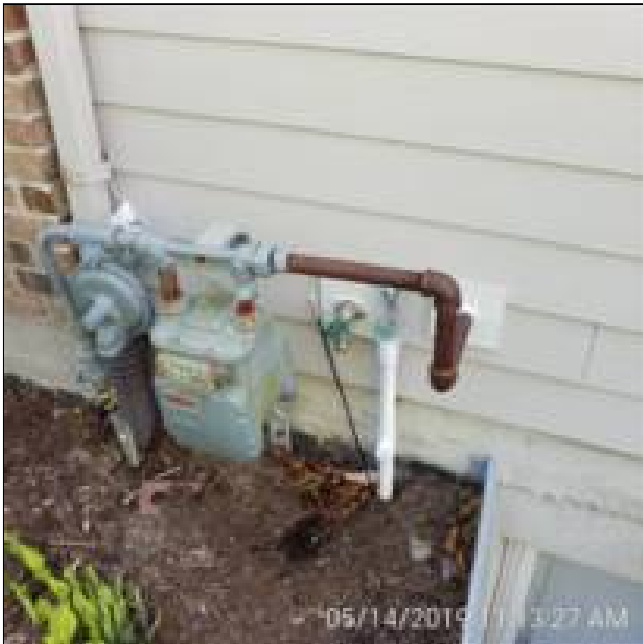
1.3 (Picture 1)

**The gas meter or pipes were rusted.**

This can over time develop into a leak.

Recommend qualified plumber to replace or paint rusted components.

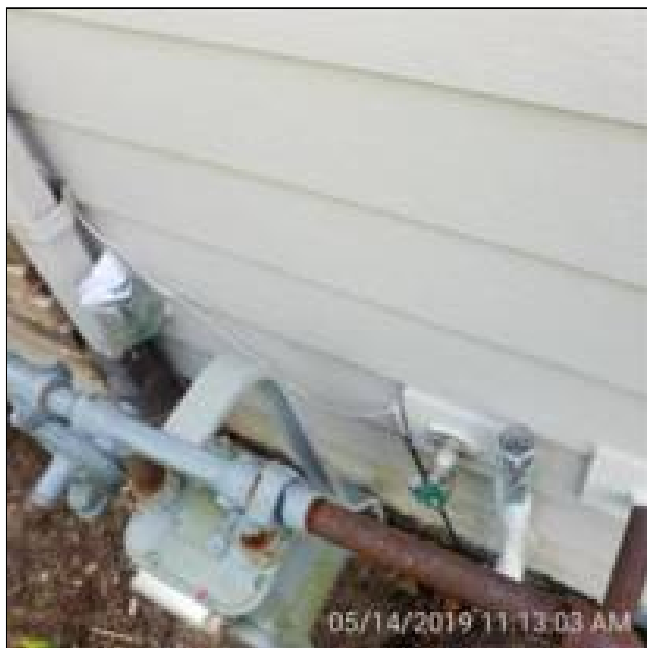
1.5 (Picture 1)

**Lawn sprinkler system was installed.**

Recommend asking current owner for demonstration prior to closing. Recommend reading manuals. Recommend asking current owner, installer, or sprinkler contractor about seasonal maintenance, testing, and repairs as needed. Recommend making sure it does not spray water on, or too close to, the home. This is recommended to prevent water damage to the home.

Note, an RPZ (Reduced Pressure Zone) assembly or device may be needed. Recommend asking current owner about this, asking town about requirements, and a qualified plumber to add the correct type of device as needed to match the town's current requirement. This is recommended to prevent backflow from a sprinkler system into the potable water supply.

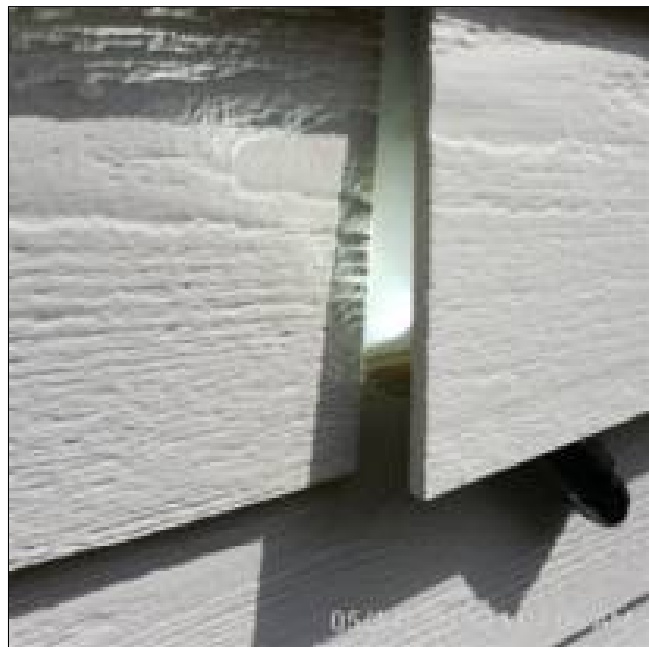
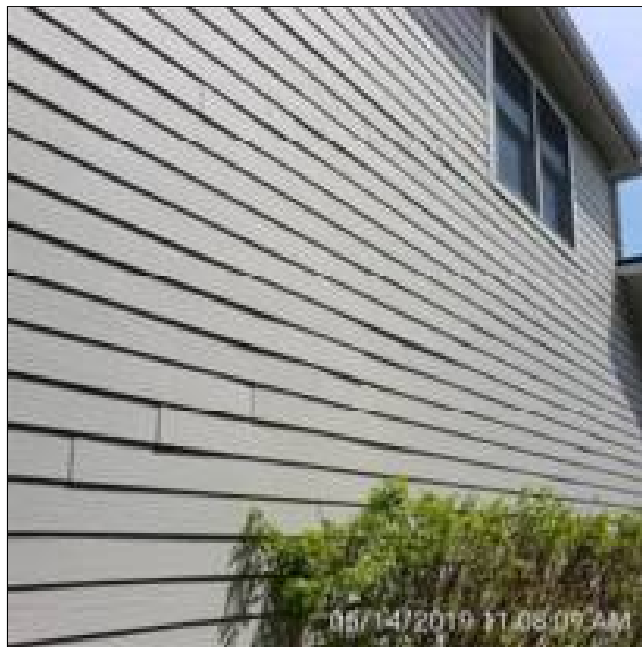
2.1 (Picture 1)

**The siding appeared to be a fiber cement or similar board often called "Hardie Board". At time of inspection the siding did not appear to have any flashing at the siding joints (normally required to prevent water damage).**

This type of product is made by multiple manufactures out of multiple materials and can be difficult to tell from painted wood. We have had mixed success with this type of product. Both the material it is made of and the installation have impacted how long it lasts. Problems typical with this type of siding include large gaps in the siding, loose siding, leaks, and rot. At one time manufacturers were recommending caulk at the joints but have discovered that caulk does not work

Recommend asking the current owner for all information regarding the type of siding, including brand and product number. Recommend researching if this siding is known for installation and product defects and further review by siding specialist, maintenance, or repairs as needed. Recommend getting copies of all receipts and documentation regarding install and all repairs.

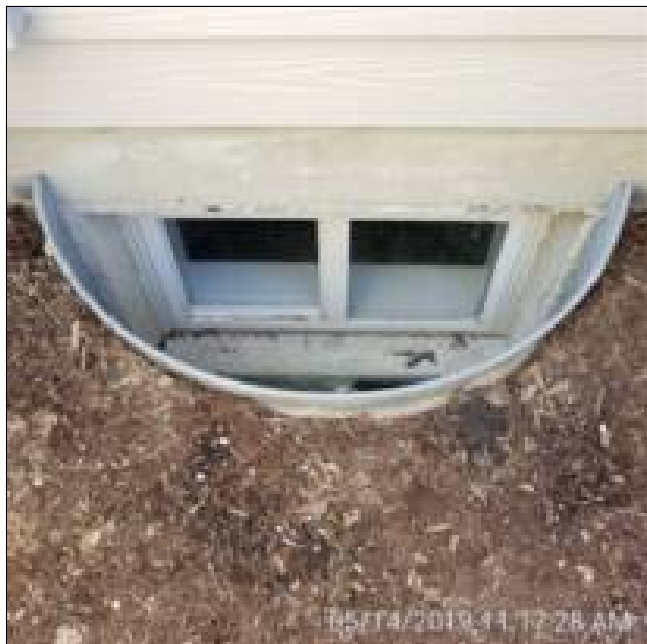
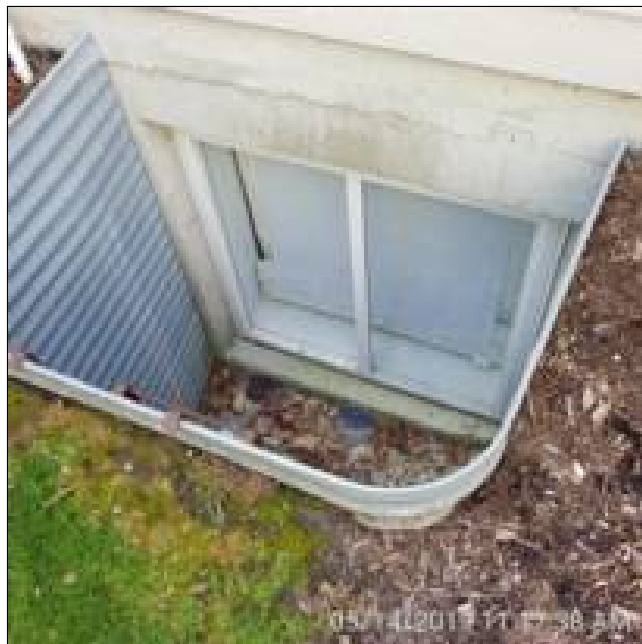
2.3 (Picture 1)

### (1) **Window wells did not have proper covers.**

Window wells, when properly maintained and covered help to keep dirt, water, and pests from damaging the property.

Recommend keeping area free of debris, adding solid covers, and installing sturdy dome covers. This is recommended to prevent water intrusion, to prevent pest intrusion, and for increased child safety. Regular maintenance of window wells is important for the property and for increased safety.

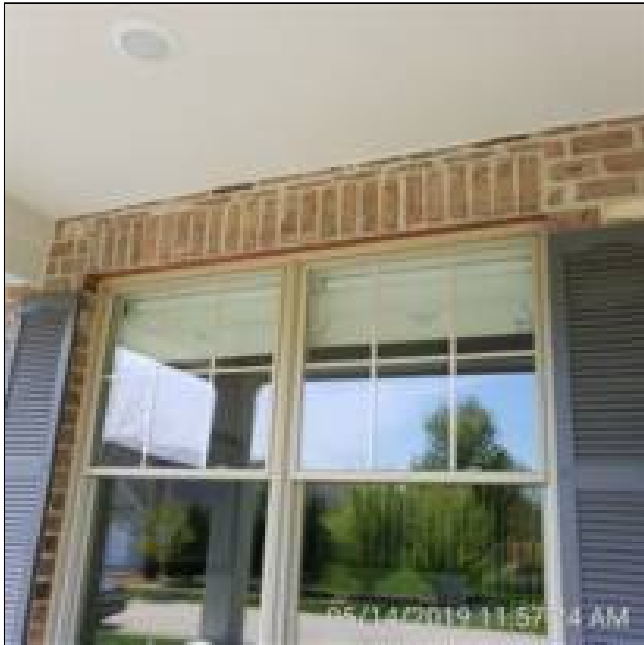
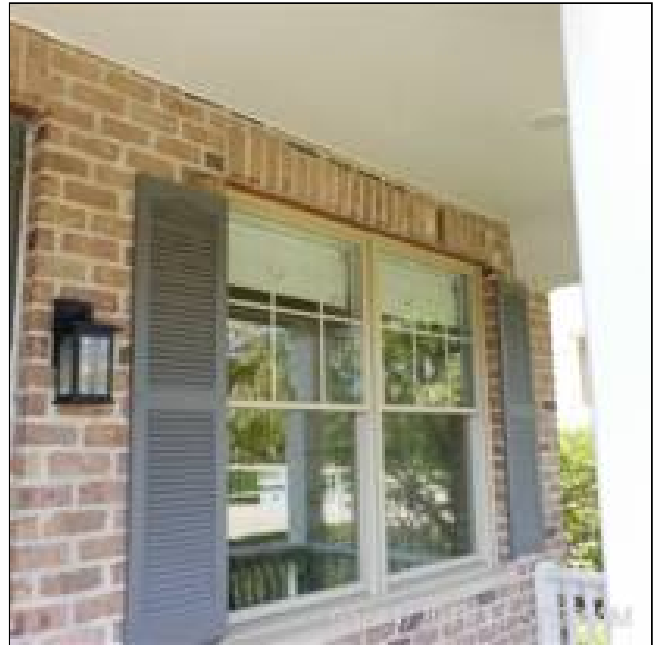
2.3 (Picture 3)

**(2) Multiple lintels were rusting, maintenance issue (paint is recommended to prevent further damage).**

Lintels are the metal structural component over doors and windows. These are structural components that require maintenance to prevent structural damage to the home.

Recommend prep and paint with paint made to prevent rust on metal. This is recommended to prevent structural damage.

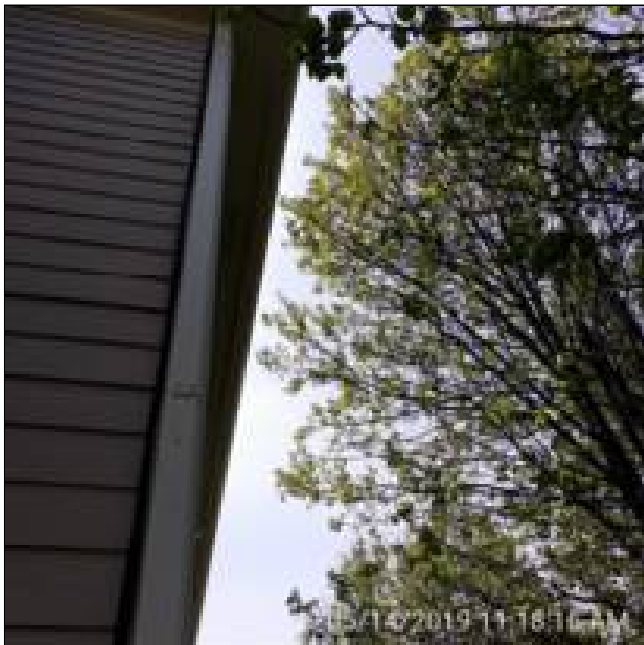
2.6 (Picture 1)

**There was vegetation close to or touching the structure.**

Vegetation close to the structure causes pest issues, water intrusion, prevents inspection, and prevents regular maintenance.

Recommend trimming any vegetation that is close to the structure, further inspection, maintenance, and repairs to prevent water and pest intrusion.

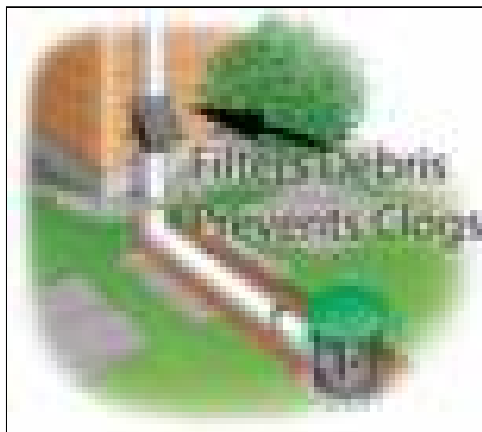
2.7 (Picture 1) Downspout Underground  
2

**Downspouts were run to underground plumbing.**

Recommend maintaining downspout extensions. For underground downspouts a plumber may be needed to clear blockages. This is part of regular maintenance and is recommended to reduce water intrusion issues. Recommend proper covers for all drains and drainage termination to prevent pest access and to prevent debris from getting in. Recommend downspout leaf diverters to prevent leaves from clogging underground plumbing.

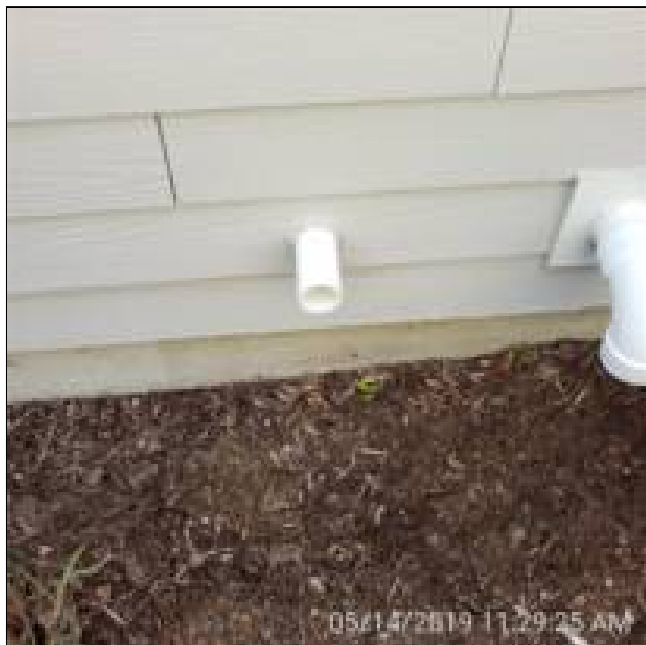
2.8 (Picture 1)

**PVC pipe was terminated in a way that may let in pests.**

Recommend qualified plumber or heating contractor to repair for proper operation and increased safety.

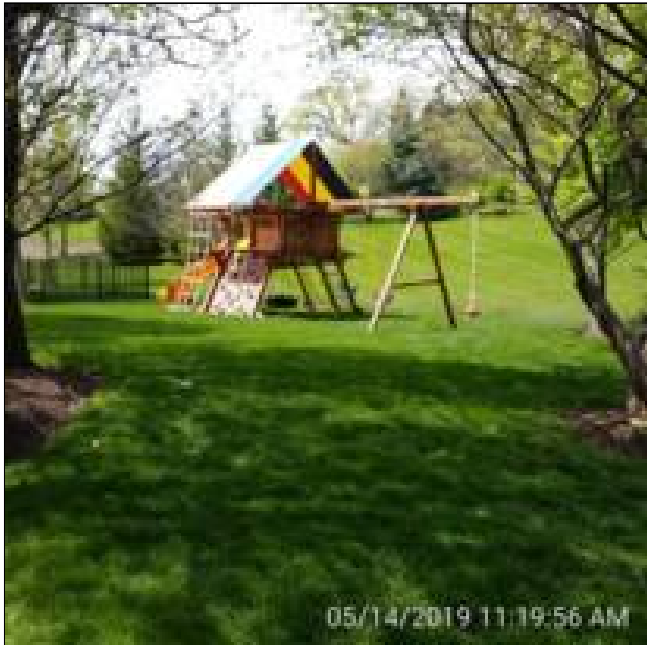
3.4 (Picture 1)

**Swing, swing set, or similar play equipment was on site.**

This is not inspected as part of the inspection but can cause safety concerns.

Recommend carpenter to inspect this equipment prior to first use. Recommend blocking access to prevent unwanted or unsafe access. ***Recommend inspecting and maintaining this equipment often for safety.***

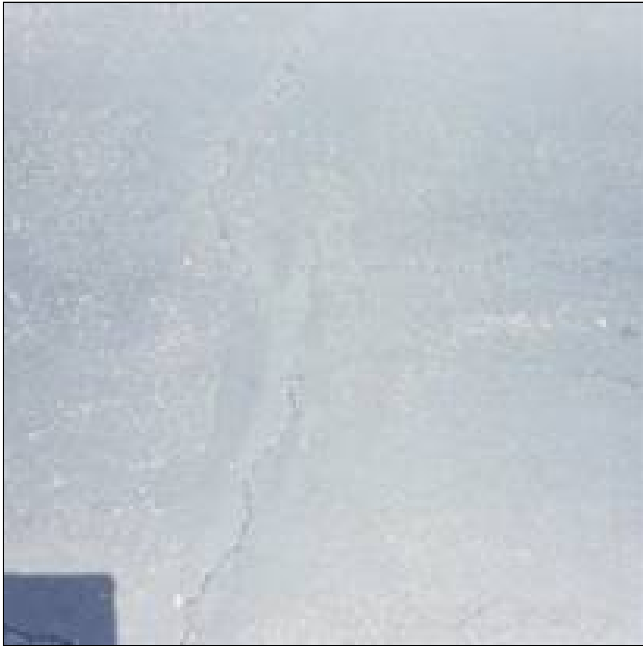
3.6 (Picture 1)

**(1) Driveway was cracked and/or surface damaged.**

Recommend driveway specialist to repair, resurface, or re-coat to extend life of driveway.

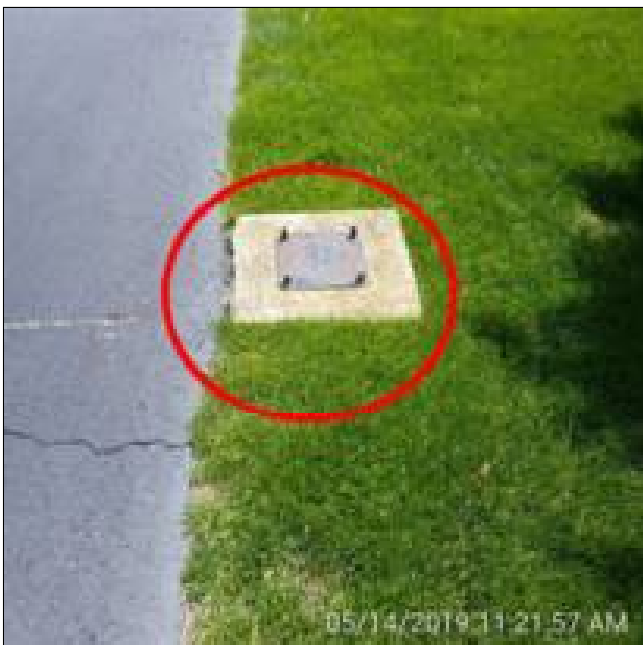
3.6 (Picture 2)

**(2) Trip hazard present (see photo in full report).**

***Recommend qualified carpenter to repair for safety.***

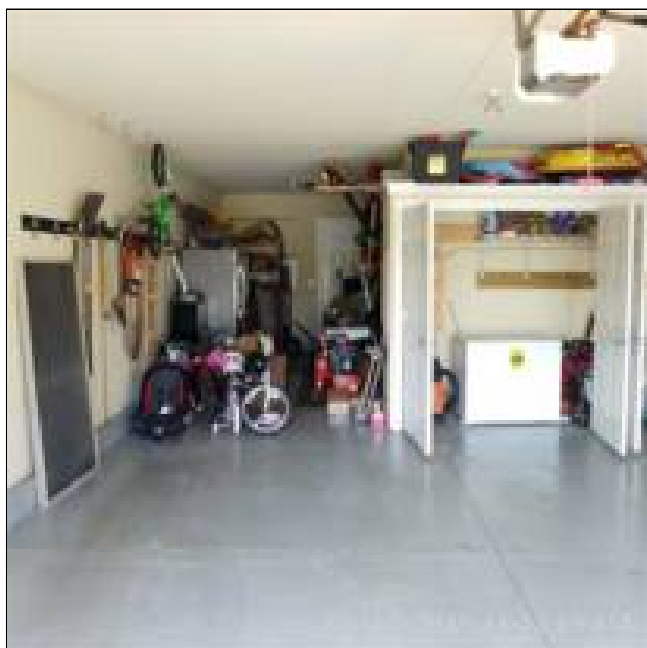
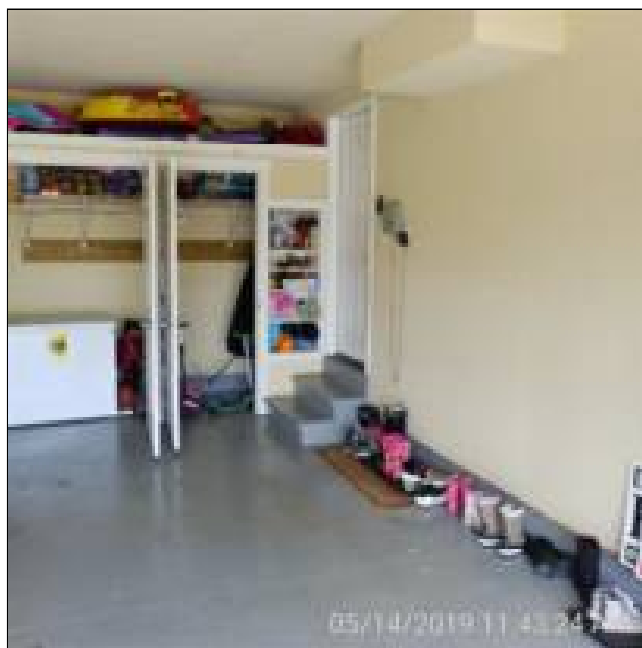
5.1 (Picture 1)

**Access was prevented due to personal items onsite at time of inspection.**

Recommend repairing access and further inspection prior to closing.

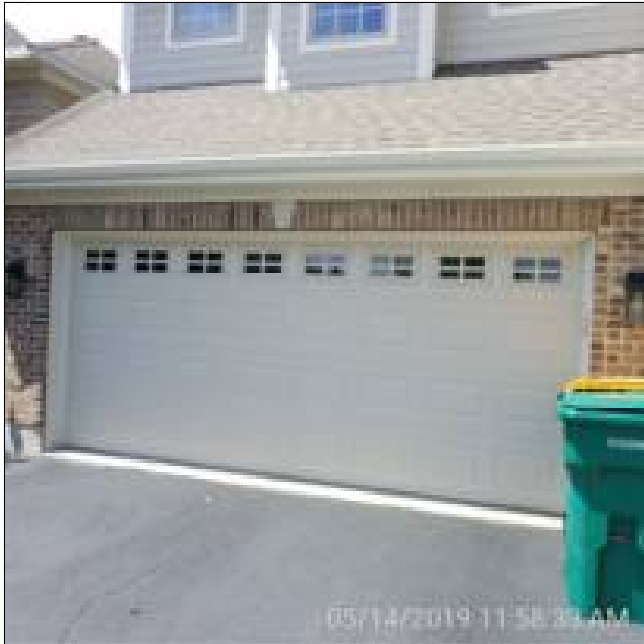
5.2 (Picture 1)

**Multiple lintels were rusting, maintenance issue (paint is recommended to prevent further damage).**

Lintels are the metal structural component over doors and windows. These are structural components that require maintenance to prevent structural damage to the home.

Recommend prep and paint with paint made to prevent rust on metal. This is recommended to prevent structural damage.

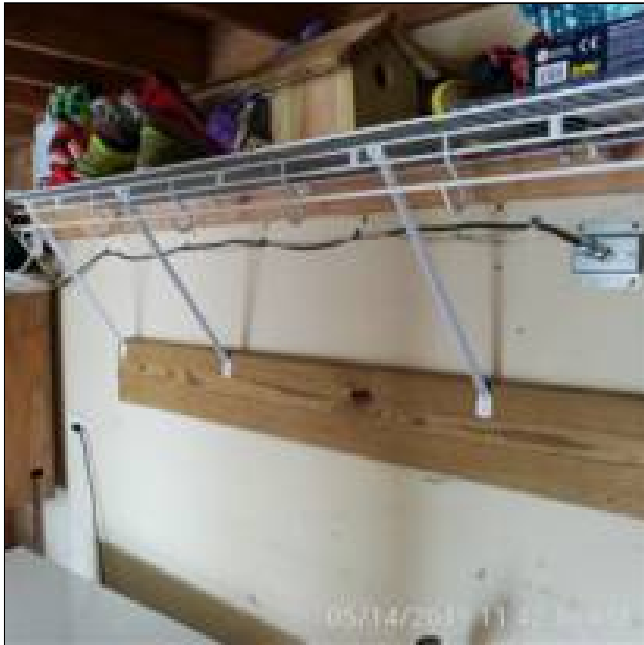
5.8 (Picture 1)

**Unknown device or appliance was found (see picture in full report).**

Recommend asking current owner about this and testing, maintenance, or repairs as needed. Recommend getting all documentation and checking functions prior to closing.

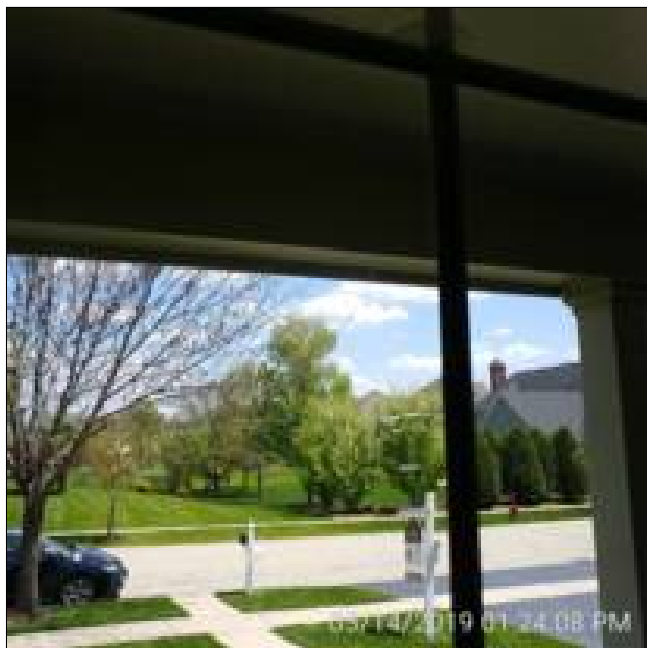
9.3 (Picture 1)

**(2) One window was cracked.**

This was found in office.

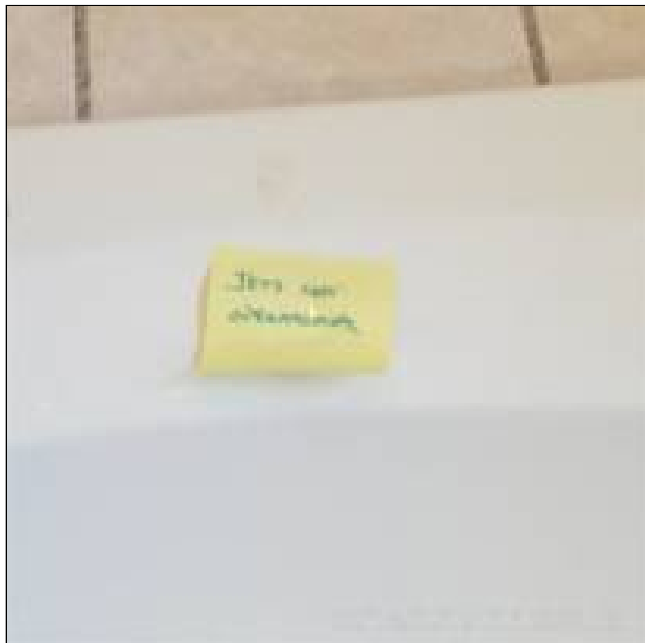
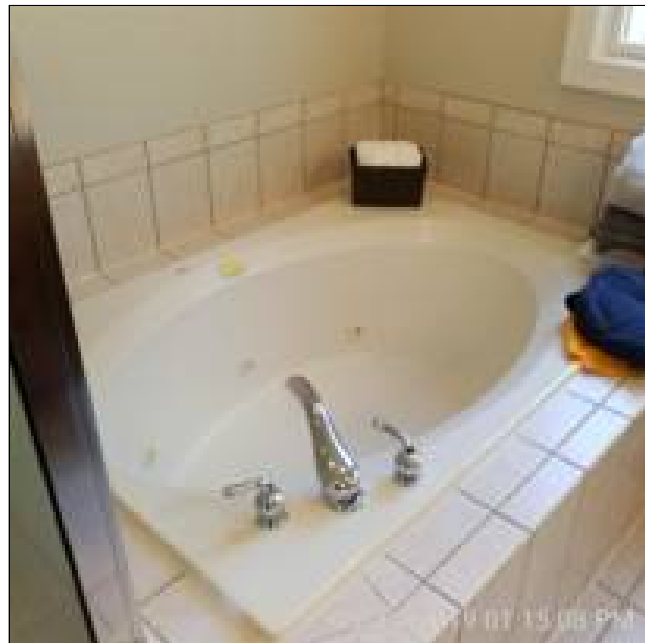
10.5 (Picture 1)

(1) **Spa jets were not working.**

Recommend qualified plumber to repair or replace for normal function.

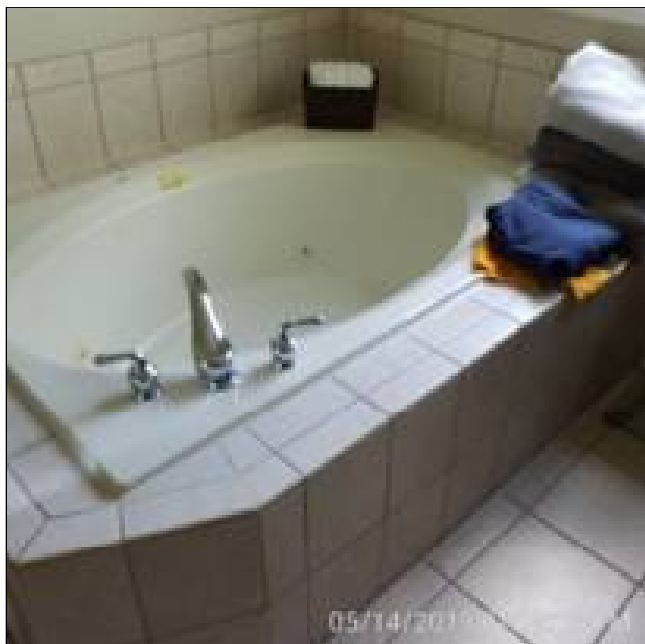
10.5 (Picture 3)

(2) **Access was not found for spa equipment.**

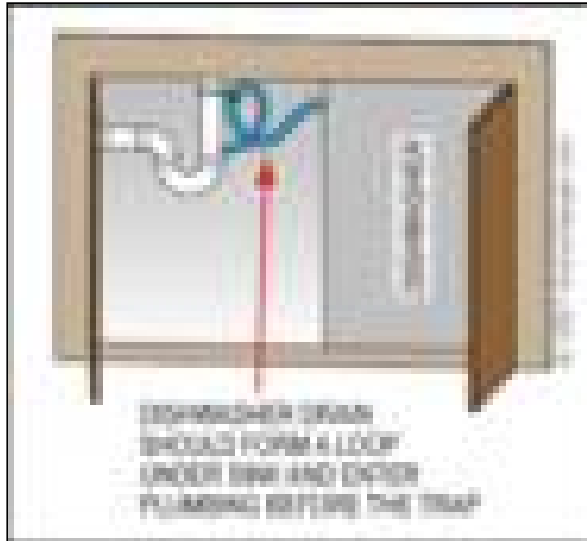
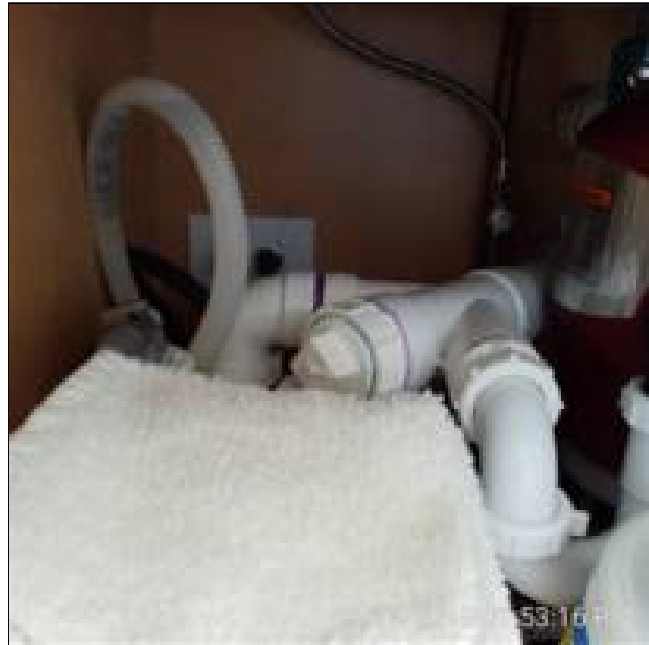
11.9 (Picture 1) Dishwasher Drain

**The dishwasher waste line did not appear to be installed correctly (no high loop and no air gap separator found).**

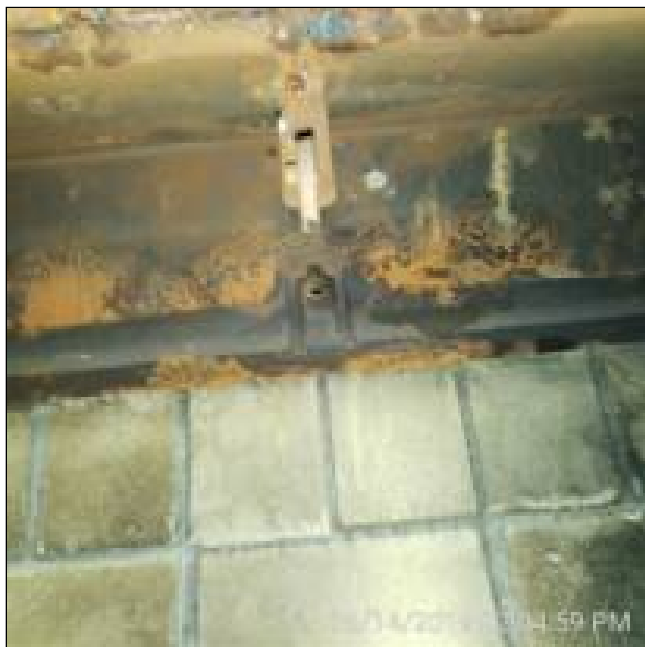
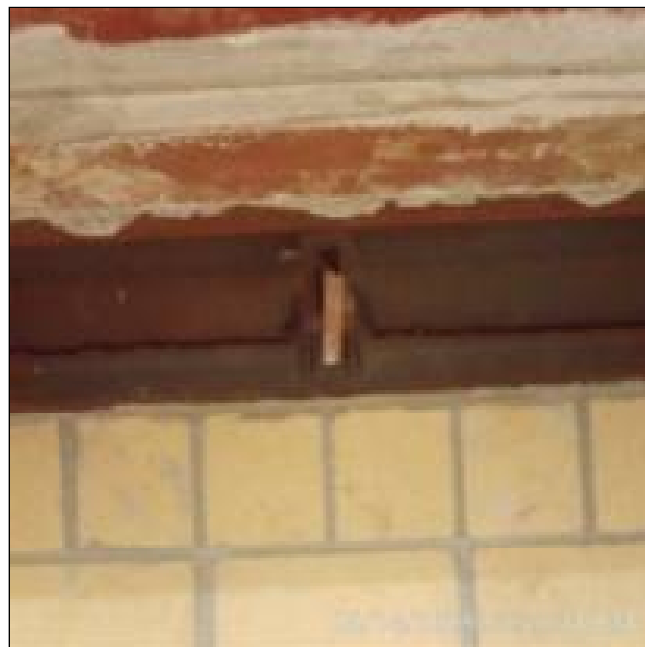
12.1 (Picture 1)

**Damper was rusted.**

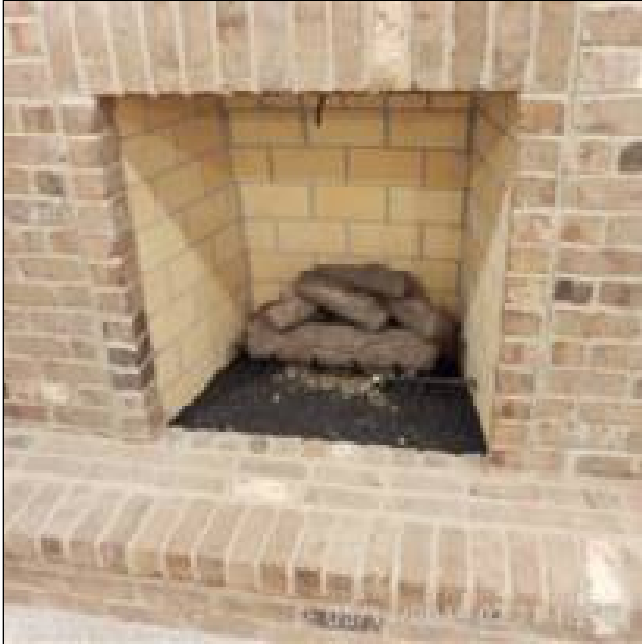
12.2 (Picture 1)

**Multiple accessories were missing including but not limited to: Spark screens.**

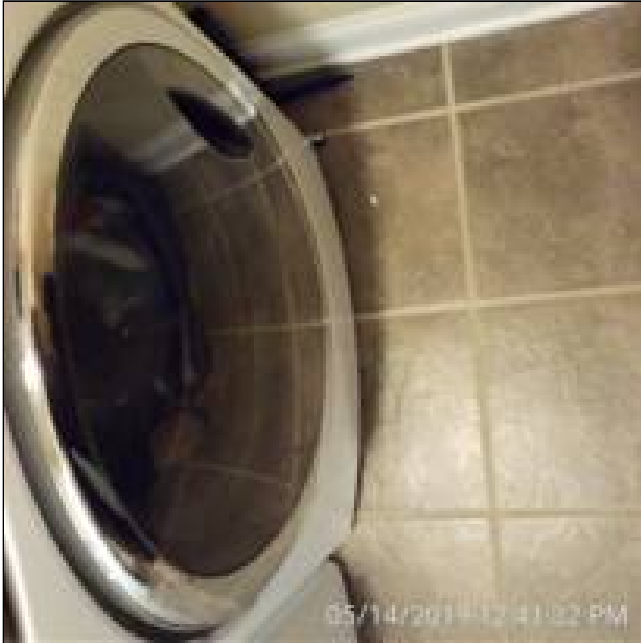
13.3 (Picture 1)

**No drain or pan was visible.**

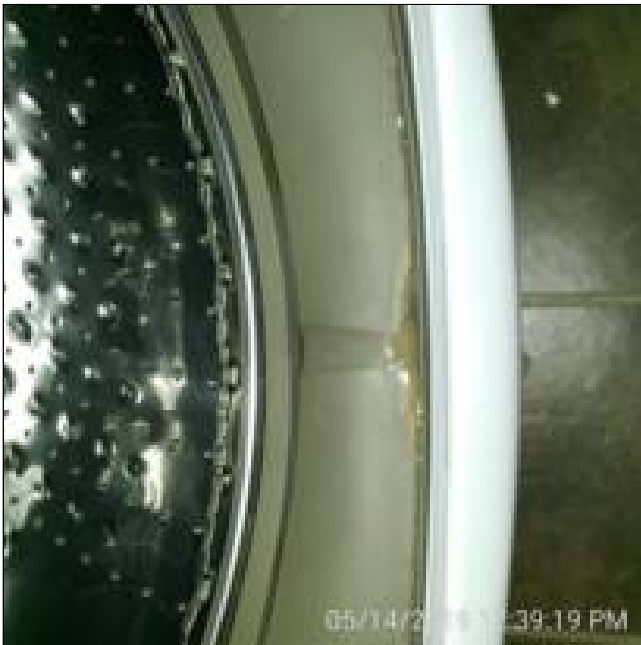
13.4 (Picture 1)

**The washing machine appeared to be the newer energy efficient type. There was visible mold at time of inspection.**

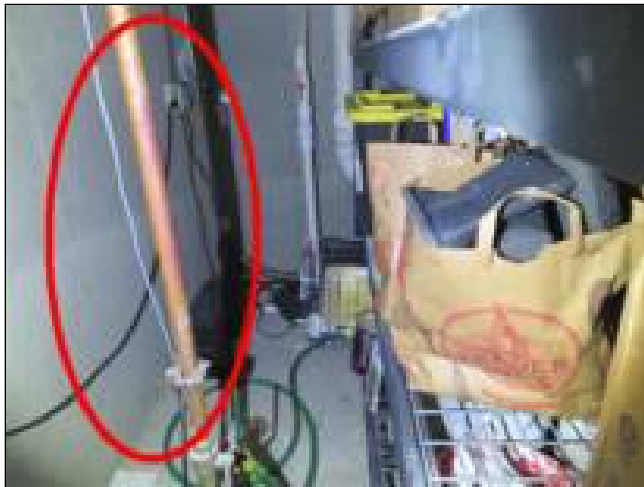
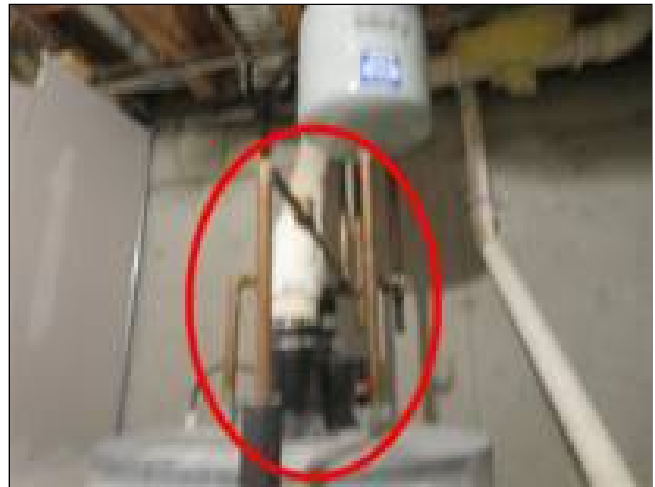
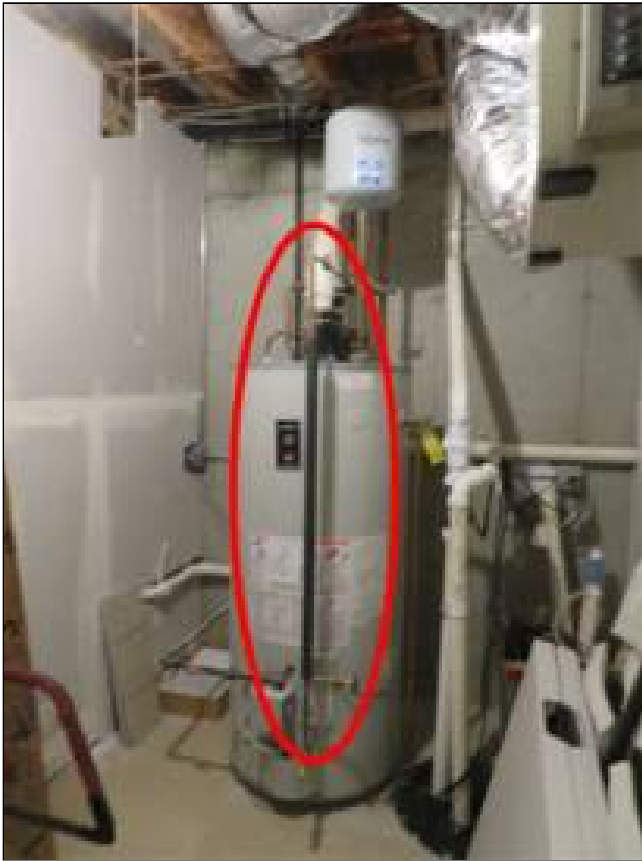
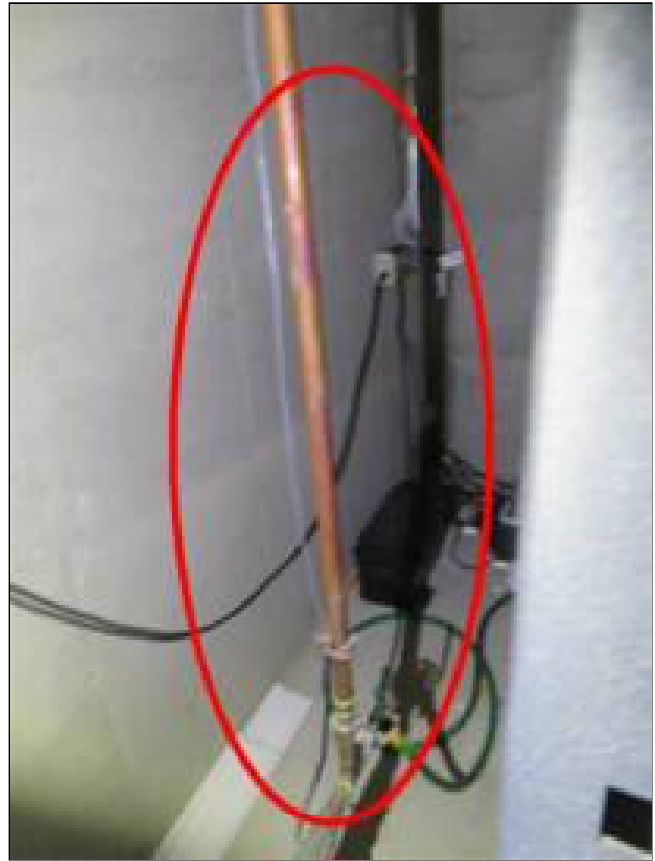
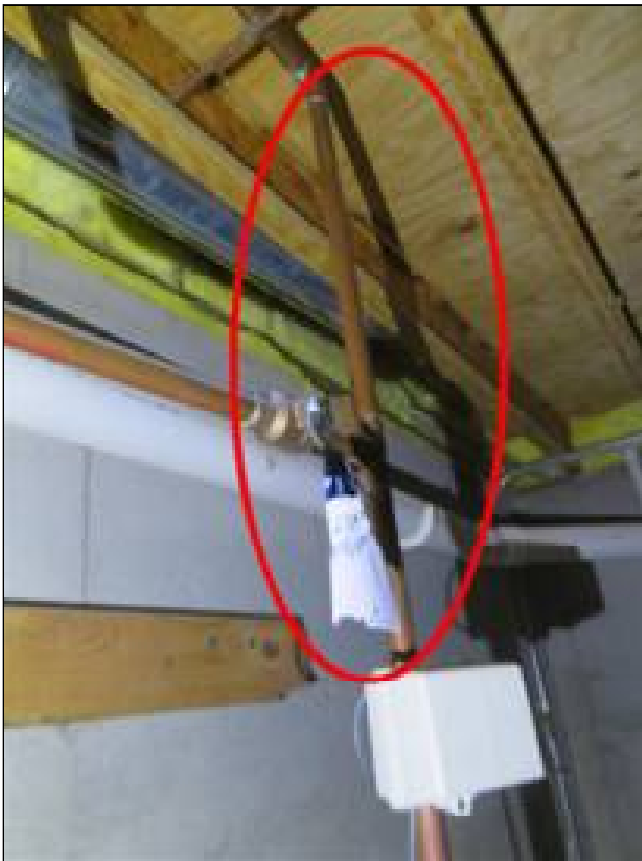
15.2 (Picture 1)

**Multiple plumbing pipes were loose or not well secured (see photo in full report).**

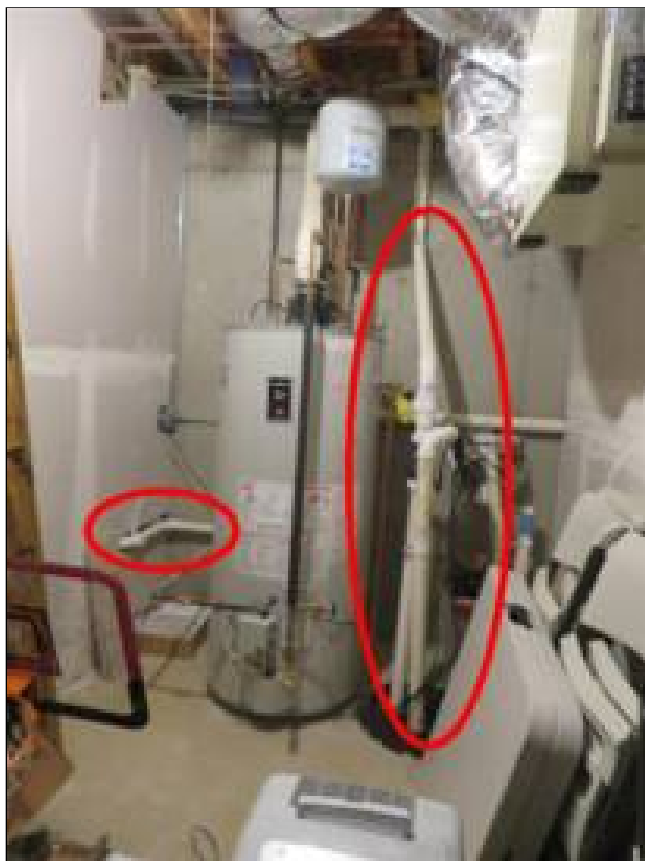
15.3 (Picture 1)

**Multiple plumbing pipes were loose or not well secured (see photo in full report).**

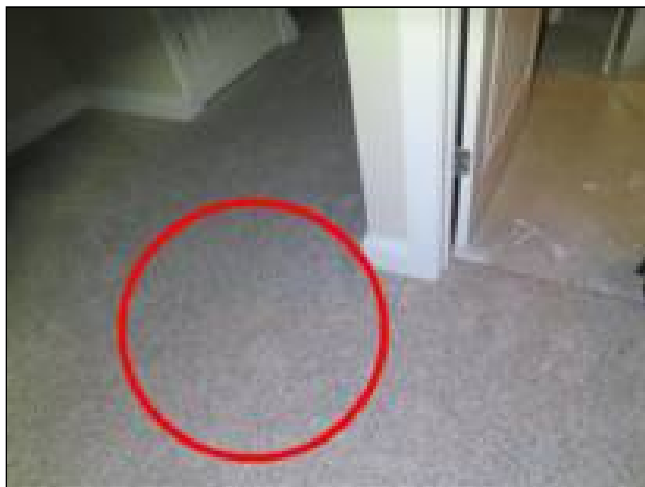
16.1 (Picture 5)

**(2) Carpet (and similar materials) are not recommended for areas that may get wet, for example, kitchens, bathrooms, and below ground level.**

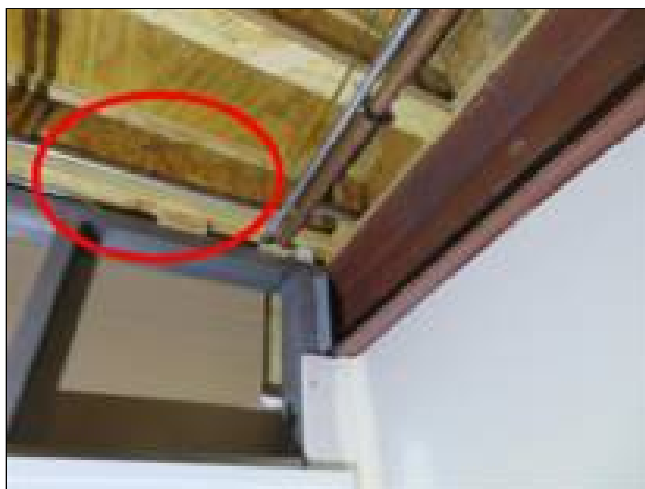
16.3 (Picture 1)

**Wood I-beams or wood I-joists were in use. These are stronger and lighter than dimensional lumber but there are some disadvantages.**

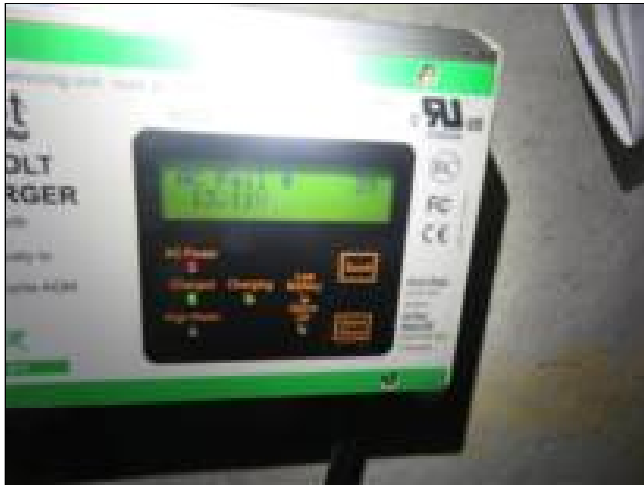
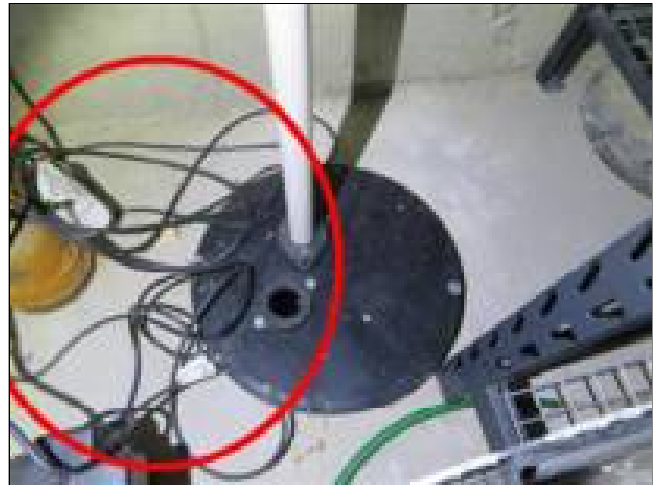
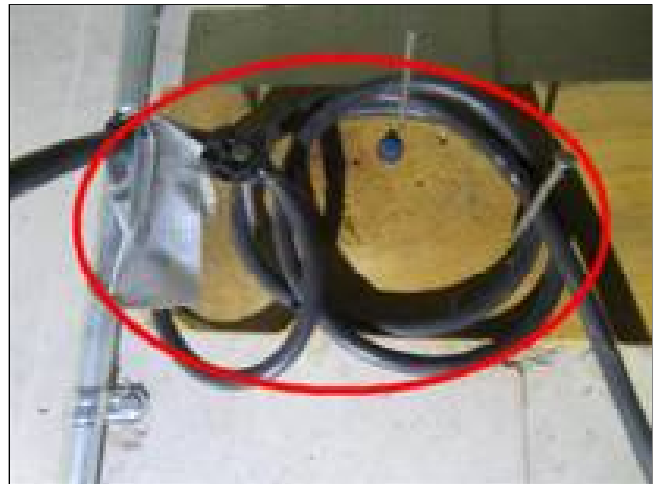
16.7 (Picture 1)

(1) **Battery backup system for sump pump electrical was connected using an extension cord.**

Recommend qualified electrician to assess and repair or replace *for increased safety*. Recommend testing equipment often to prevent water damage. Recommend regular maintenance. Recommend cover that seals but has a view window for inspection and can be removed for testing, maintenance, repairs, or replacement.

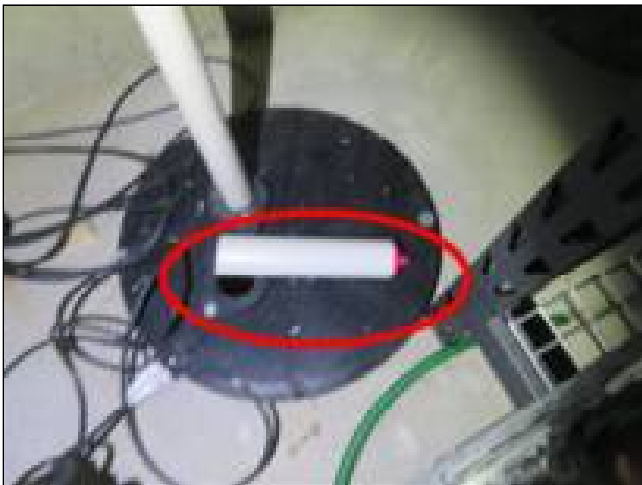
16.7 (Picture 6)

(2) **Note, the sump pump had a PVC pipe and plug to cover a hole that was not used.**
