# Inspection Report

## Sample Customer

123 Sample St  
Your Town IL

### At Home Inspections, Inc.

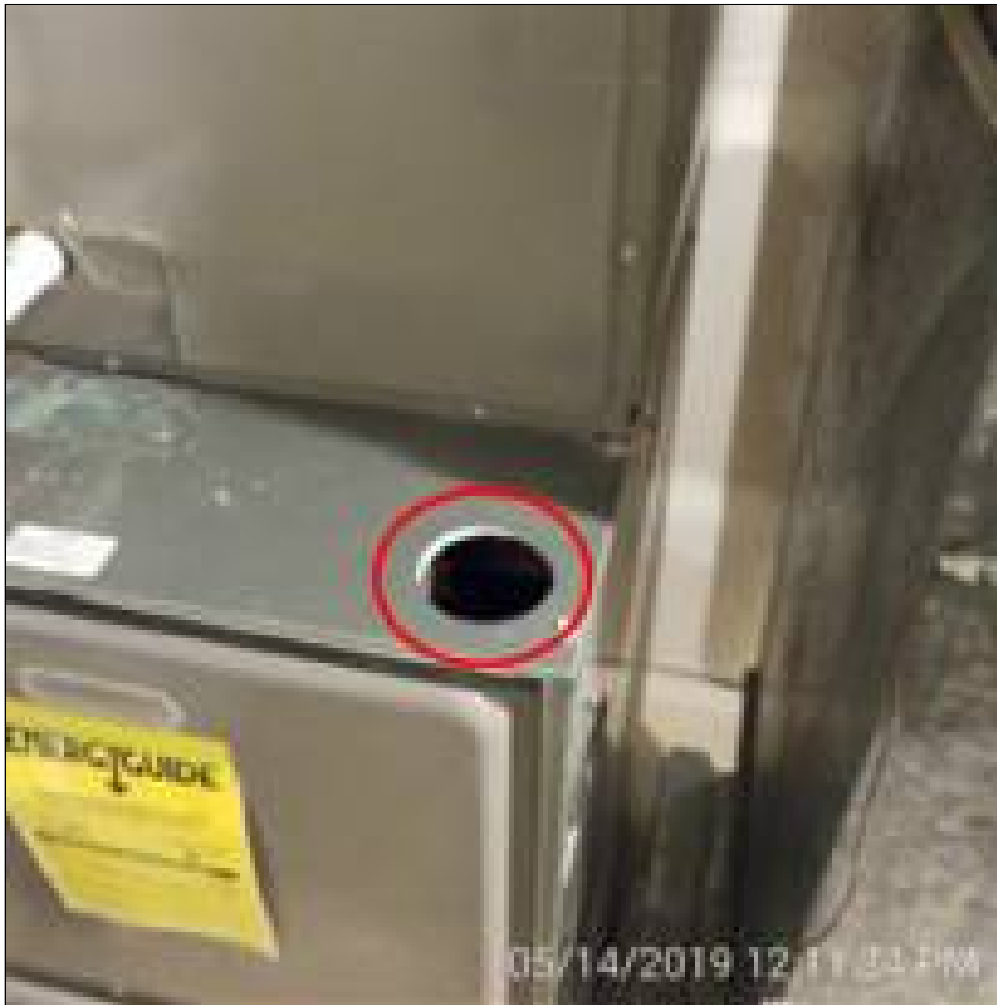
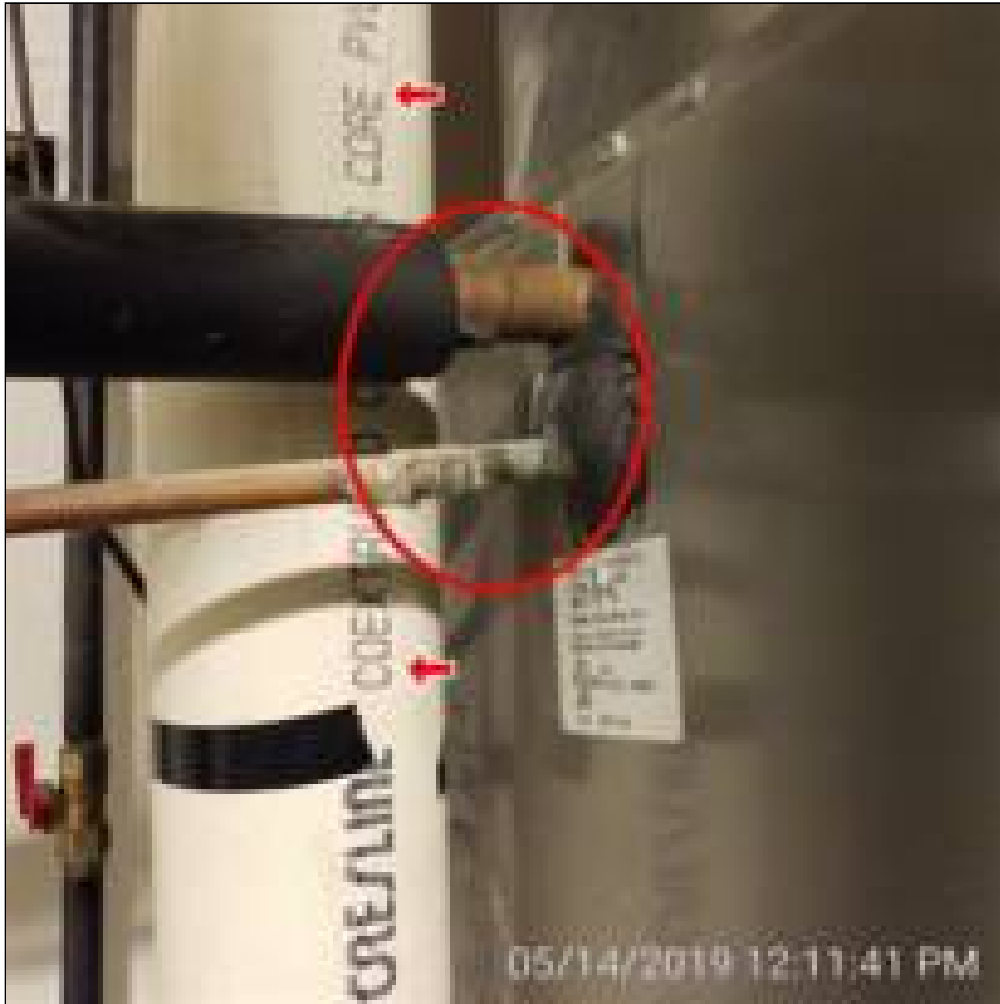
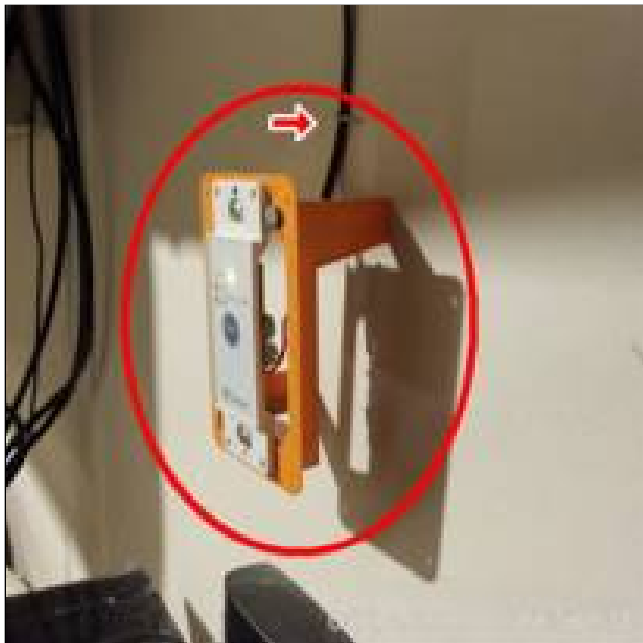
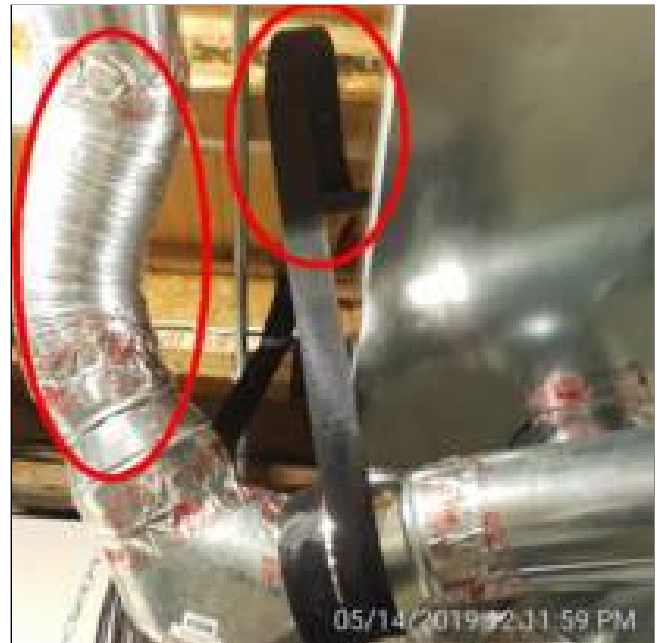
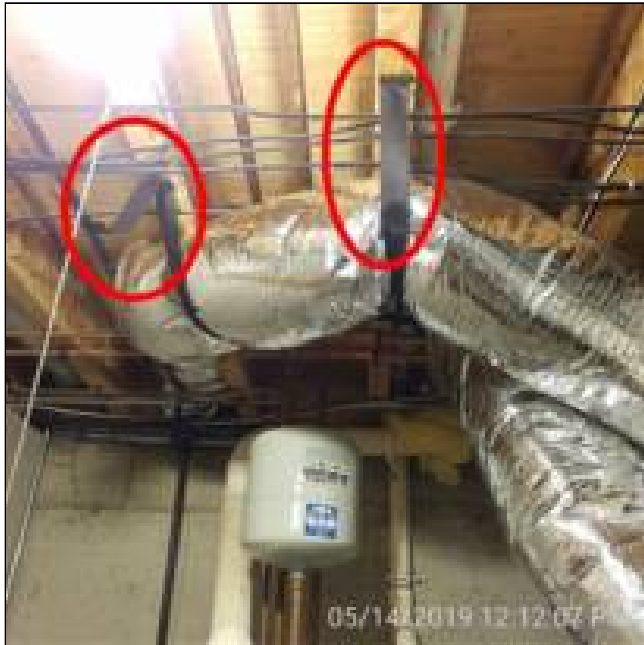
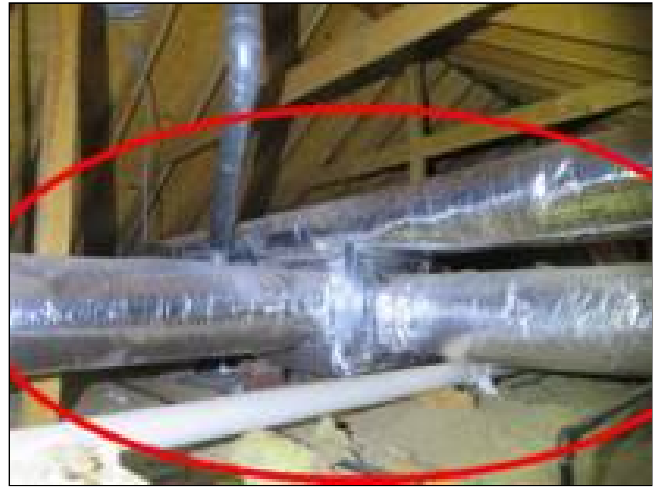
17.2 (Picture 1)

**(1) Heating equipment was installed that did not appear to be installed by qualified professionals and/or was not up to normal professional standards. For example:**

Recommend getting all paperwork for work done including receipts, warrantee information, and permits.

Recommend confirming the qualifications of workers and qualified installation specialist to review further. Specialist may discover other issues, including safety issues.
